Pollard Middle School

Needham, MA

Existing Facility Assessment – August 5, 2025

Prepared for HMFH Architects

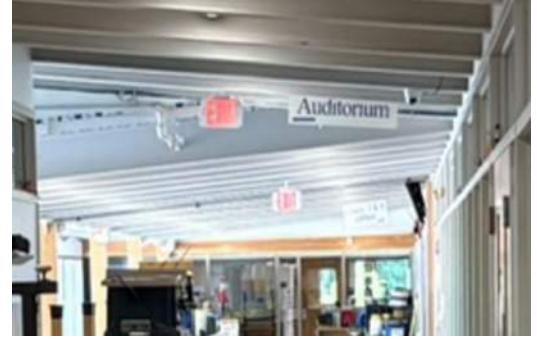
While seating was replaced within the last 5-7 years, many show signs of wear including torn fabric, chipped armrests, and missing row labels and tag numbers. The current semi-circular seating configuration is counterproductive to the shape of the theatre and the audience's relationship to the stage.

Auditorium sign at ceiling

- Widen access ramp(s) to stage, as well as paths to front row of the auditorium to improve accessibility routes; confirm grades of ramps meet ADA requirements.
- Create designated wheelchair locations with companion seats at the front and rear of audience seating.
- Repair broken and worn-out seats.

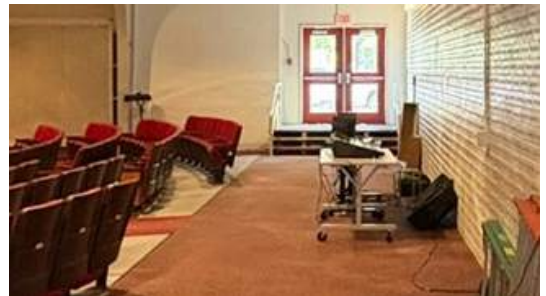
Inside the auditorium, seating appears to have a gentle enough slope to meet ADA guidelines. However, the current layout, along with lighting and sound operator positions, may restrict clear egress paths.

Exit doors with steps at back of house, operators in egress

- Provide clear, wayfinding signs so audiences can find the nearest available restrooms.
- Replace existing seating with new seats; reconfigure the layout to optimize sightlines, to increase the seat count, and to create a position for lighting and sound operators that does not cut into the egress.
- Refer to Base Repair ADA requirements and operator positions.

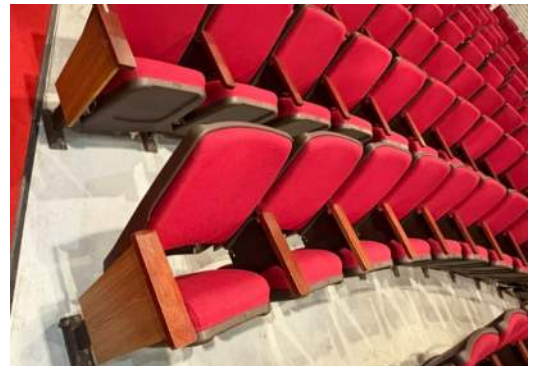
Seating missing labels and tags

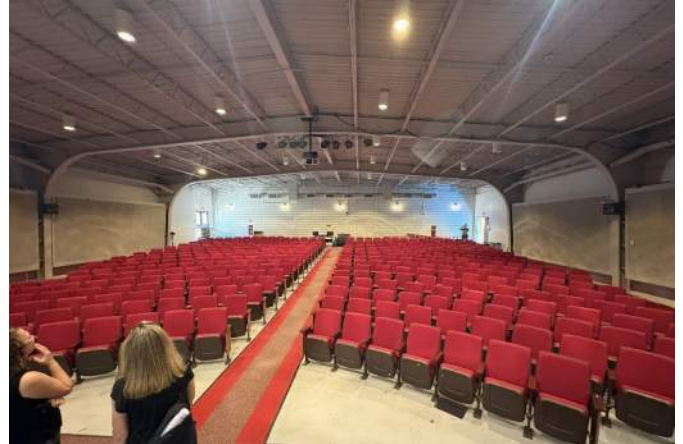
Auditorium seating from onstage

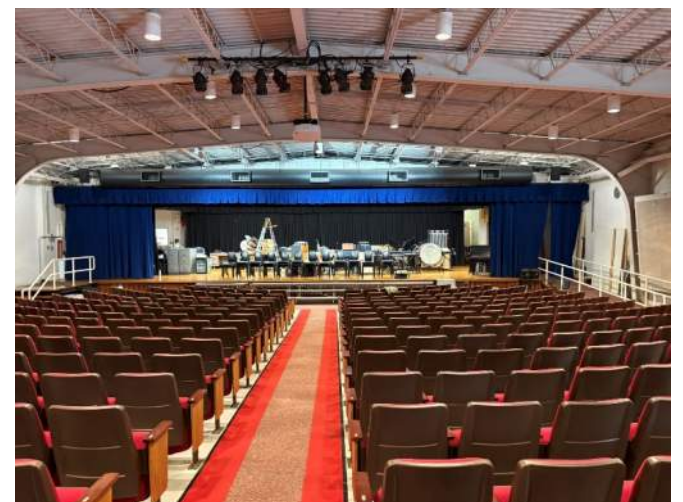
Stage view from the seating

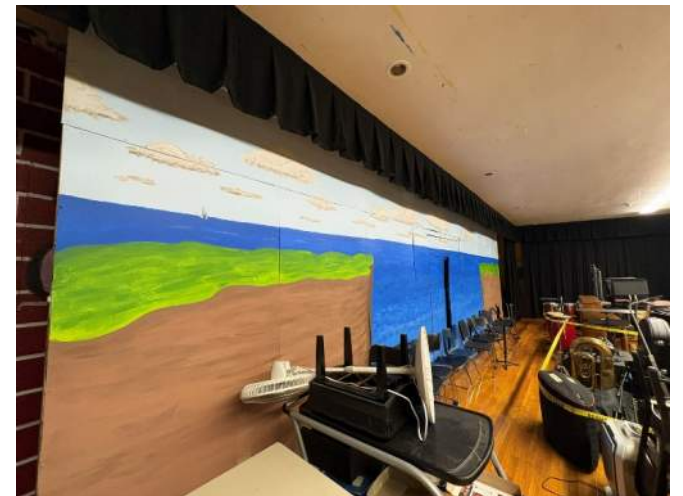
There are no sound and light locks at the entrances to the space, and the entry doors at the rear of the house have windows which let in a considerable amount of light. At the upstage wall, a makeshift crossover has been built from untreated lumber, and only allows 2'-0" clear path.

Makeshift upstage crossover

- Install insulation and HVAC services in the auditorium.
- Demolish the upstage crossover and replace it with drapery system which allows for a wider and accessible circulation path (See Rigging and Draperies section for more information).
- Relocate light and sound operator position to improve egress paths.

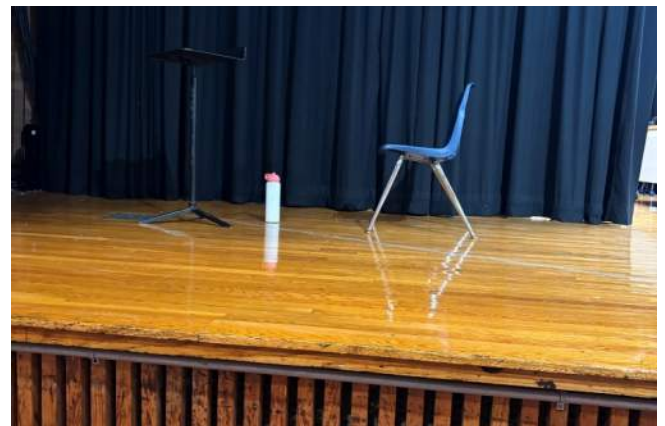
The stage floor is believed to be non-flame treated hardwood, varnished to a high shine. It's currently too small to host many of the music ensembles in the school district. The stage floor should also be load rated and is required by code to support capacities that are in alignment with usage of the space. The first 9'-0" of the stage, measured from the downstage edge running fully across the width of the space, is hollow and is believed to be plenum space for The HVAC return air (to be confirmed).

Stage floor

- Replace the existing stage with a load rated, flame resistant floor construction.

- Remove and replace the existing stage flooring; new flooring to be constructed of approved materials meeting NFPA, IBC, and/or governing codes.
- Increase stage size to meet programmatic needs without reducing seat count.
- Create storage space under the new stage for risers and equipment.
- Add a system of modular platforms to be able to expand the stage area to serve larger ensembles as needed.

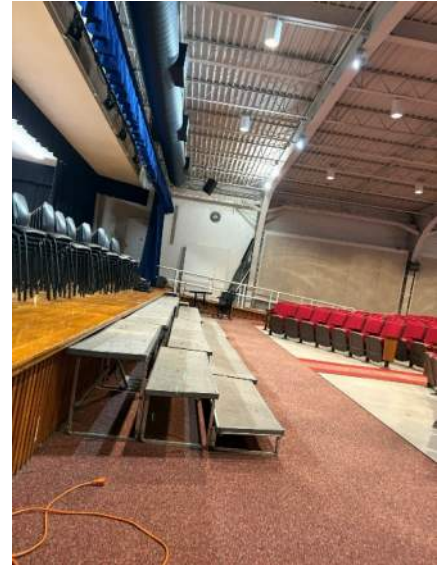
There is a set of choir risers in front of the stage that are visible at all times, as there is no alternative storage for them. These risers are well used and are in need of replacement given their aging state and condition. Additionally, they're not large enough for current ensemble size and lack proper guardrails and side steps.

Choir risers

- Replace choir risers with new models that have modern safety features, load capacity, and are sized to support the increased student enrollment.

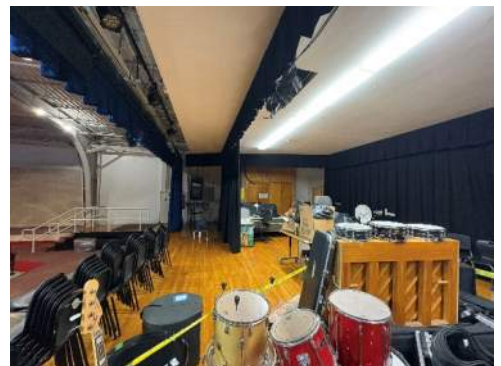
Existing ceiling overstage with draperies

Drapery System: The main curtain and valance were replaced within the last five years and are in good condition. These are currently hung on two of the three steel pipes suspended downstage. Travelers located mid, up, and side stage are about 10-12 years old. While functional, they're in need of cleaning. Existing drapery is designed based on the current track and ceiling conditions and may not be compatible with future rigging or layout changes.

- Have a Physical Engineer (PE) survey the ceiling structure to determine exact, allowable loads of building.
- PE to determine if pipe grid and performance equipment payload of 5000lb can be added to existing structure.
- Add 10' of length to the current lighting position over the audience to allow the full width of stage to be lit.
- Add a second lighting position along the upstage wall to be able to light music on stands of performers from above.

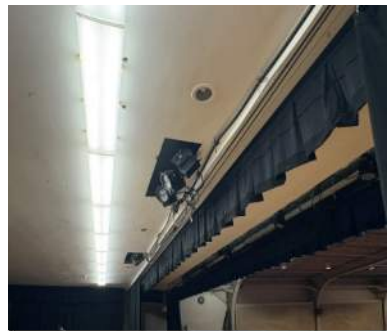
Infrastructure: The ceiling overstage is made of sheetrock and is suspended from the building's steel roof structure. It sits approximately 11'-0" above the stage floor, with an additional 3'-4' of height to the steel roof. The ceiling contains linear work lights and a small number of downlights, but only the work lights are operable. Two rope operated curtain tracks are mounted directly into the ceiling. Additionally, three steel pipes are suspended near the downstage area and there are two cutouts in the ceiling for limited mounting access.

Sheetrock ceiling over stage

- Demolish the overstage sheetrock ceiling to gain additional height over the stage, gain access to mounting locations, and improve production capabilities.
- Add another front of house pipe of equivalent length, and a vertical pipe (box boom) position to each side of the auditorium to allow for better lighting of full stage and choir in front.
- Add a pipe grid overstage to allow lighting to be suspended anywhere over the performance area to provide adequate lighting coverage and flexibility for the stage.
- Supply new draperies for modified height above the stage which includes the masking draperies, traveler, main curtain, and an upstage tracked drape which can be deployed to create an accessible crossover.

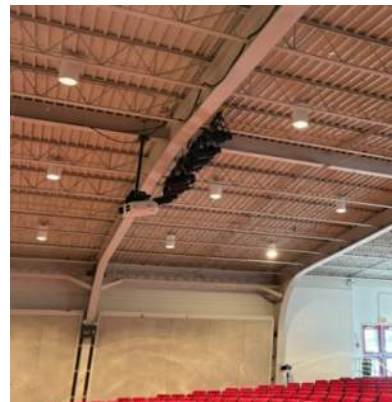
Lighting Positions: There is one pipe suspended over the audience providing front of house lighting positions. Of the 3 steel pipes over stage, one supports six LED PAR lights. The ceiling currently hosts a small number of Fresnel fixtures. There are no side lighting or box boom positions.

Lighting suspended over audience

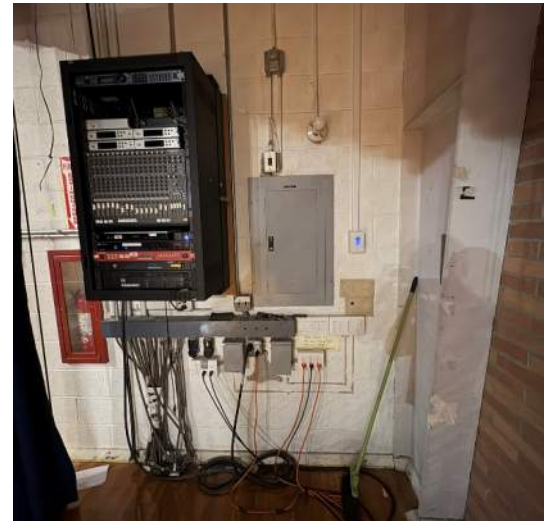
Projection System: A roll-down projector screen is mounted at the front edge of the stage, and is paired with an small, low lumen projector mounted over the audience. Both are undersized and underpowered for the size of the space. The cable serving the projector is partially free run before transitioning to conduit as it enters the AV rack mounted stage right.

Existing stage right audiovisual equipment rack

- Install a suitable assistive listening system with a code compliant quantity of receivers to adhere to ADA regulations.
- Install A/V control system and infrastructure to support show feed to back of house and lobby spaces.
- Install a new audiovisual rack, connection plates, and associated infrastructure around stage and auditorium for A/V signal distribution.
- Install a wired, party line production intercom system for communication between operator location and backstage.

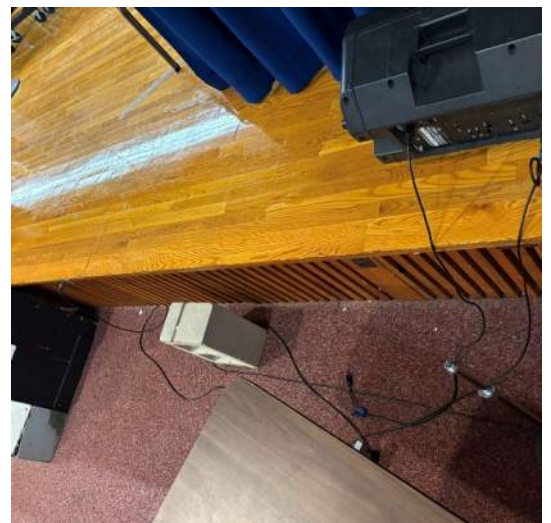
Audio System: There are two point-source loudspeakers mounted at far left and right sides of the proscenium. There is some audio signal processing equipment that is outdated and appears to be non-functional. This loudspeaker system is underpowered for the size of the auditorium and does not provide enough high-frequency coverage for reliable speech intelligibility. There are four microphone inputs at the front of the stage, however there are no corresponding output faceplates. All loudspeaker wiring is free run from the AV rack to either onstage monitors, the console back of house, or the loudspeaker system suspended overhead. The existing sound console is functional and there is a wireless microphone system that is functional, but outdated.

Existing stage monitor and cabling

- Replace audio console with modern, networked model.
- Replace stage monitoring loudspeakers with higher power, lower profile model.
- Provide a microphone package suitable for the anticipated programming.

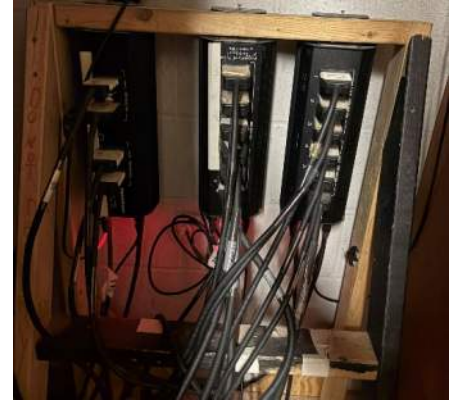
Infrastructure and Power: There is no permanent lighting and electrical infrastructure in place, and all cabling is free run. There is no installed aisle or step lighting in the space, and overhead house lights are left on at a low-level during performances for safety. A set of temporary dimmer packs are mounted in the stage right closet, with cables intended for temporary use run from these packs out to various places around the venue to power lighting. While the main building power supply is below the theatre, there is no dedicated power to support theatrical systems and equipment.

Temporary dimming packs mounted in a closet

- Install permanent DMX controlled dimmer/relay panel, conduit, wiring (infrastructure), and receptacles to replace the existing temporary system; power and data should run between the new panel and all existing lighting locations as well as to key control locations.
- Replace existing house lights with fully dimmable, architectural LED fixtures and add an architectural control system to allow for integration of house lighting with performance controls.
- Add button stations at all entrances to allow control of basic lighting at entries and exits to the space.
- Install LED aisle and step lights to provide code minimum egress lighting during performances along egress paths within the auditorium.
- Add a small collection of LED fixtures to replace existing inventory and to allow full illumination of stage.

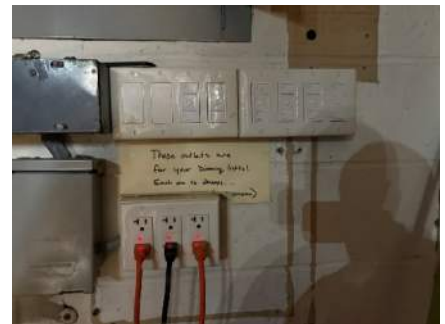
House light controls

- Refer to Base Repair section for additional upgrades.
- Add house light wall dimmers to control house lighting.
- Add a quantity of static spot and wash LED fixtures to serve the majority of programming.
- Add a quantity of lighting power and data cable to support additional fixture inventories.

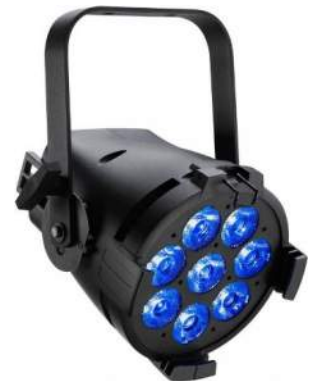
LED wash fixture
